ABS/ASC-T Pump Block Refurbish: Part-1: Disassembly.

Applicable to: 840ci (M60 & M62), 850ci (M73)

June 2011

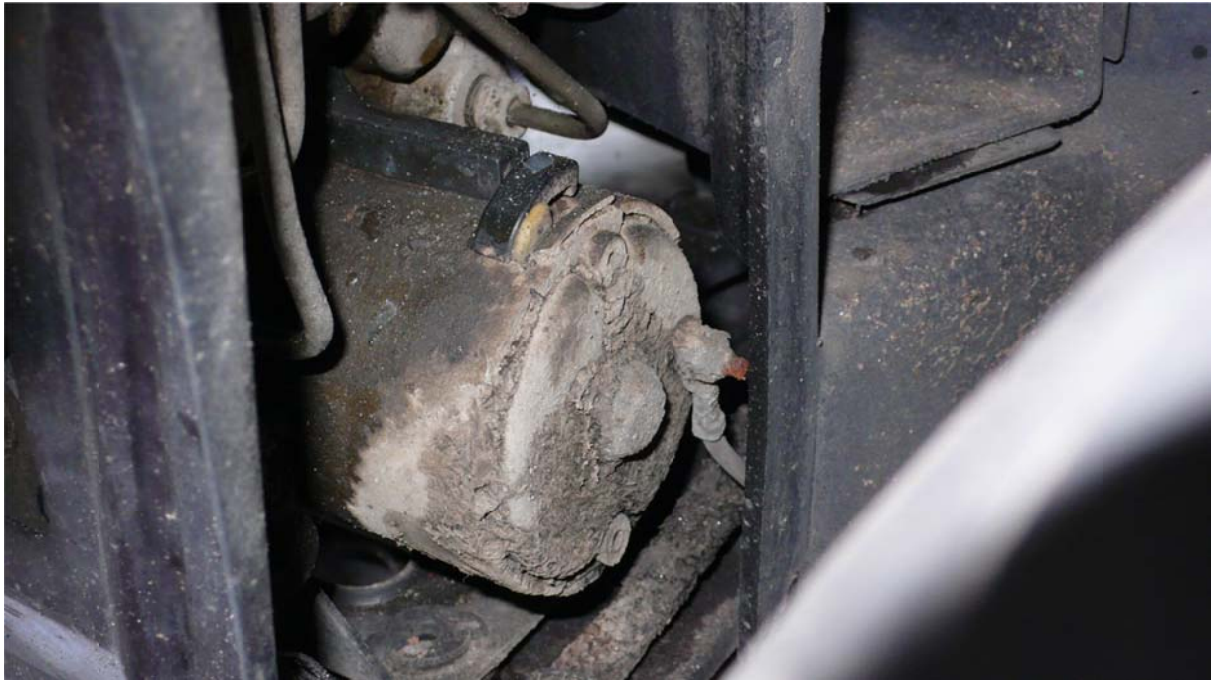
Picture-1: Before Cleaning

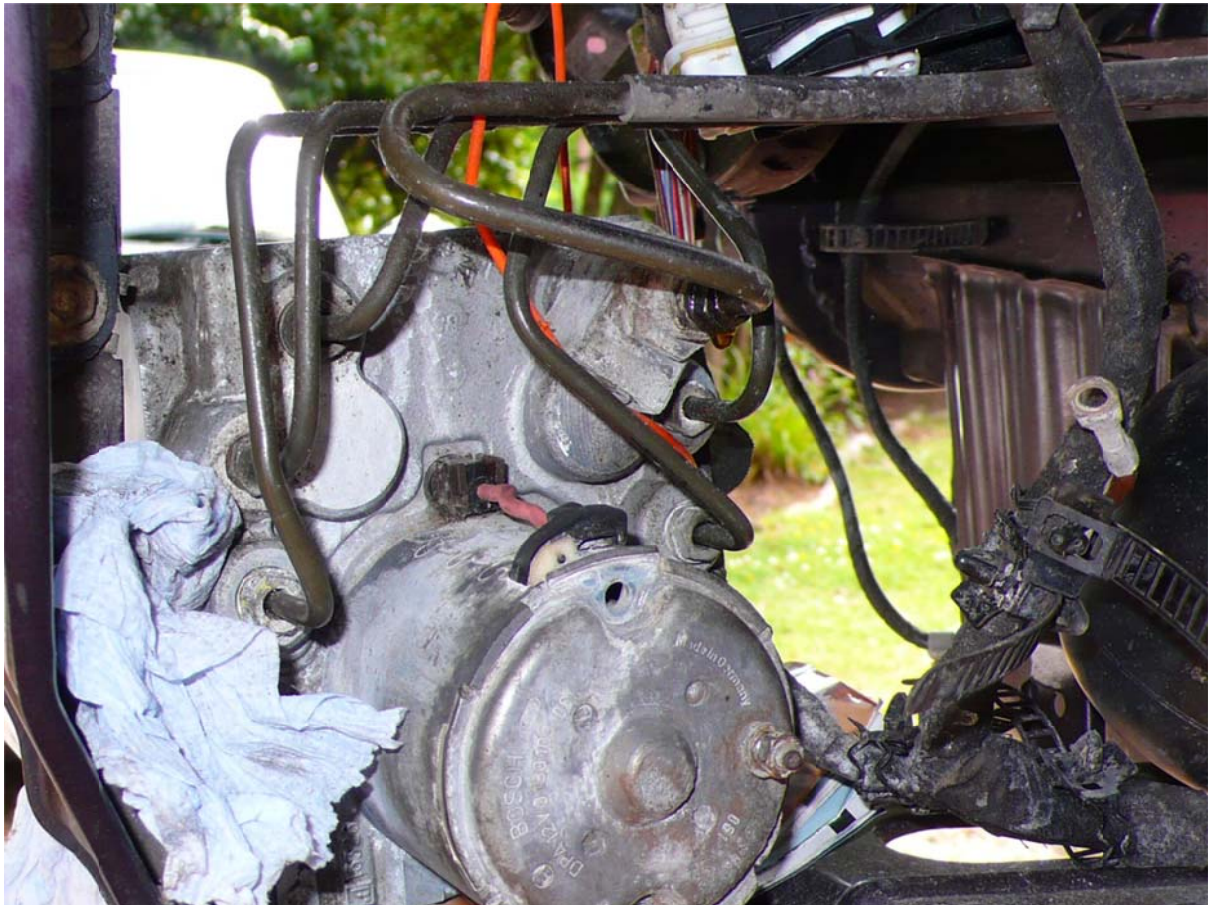
Picture-2: After initial cleaning (one Torx screw removed)

1. Clean the unit as much as possible, while still mounted on the vehicle. (Pic-2)
2. Disconnect the ground wire on the rear of the motor.
3. Disconnect the main cable connector from the front of the unit (slide-up locking mechanism).

4. (This is probably the hardest part.) Clean the two Torx screws on the rear of the motor and apply WD40 or similar to the heads to help with any corrosion between the screw head and motor body. Using the correct Torx bit on the end of a small ratchet, carefully loosen but do not completely undo the two screws. They are also held in by Loctite and may require considerable effort. If this fails, use a Dremel with cutting disc (or similar) to cut a slot across the screw head and then undo using a large flat-blade screw-driver. This step could be carried out later, but doing it now takes advantage of the unit being secured.

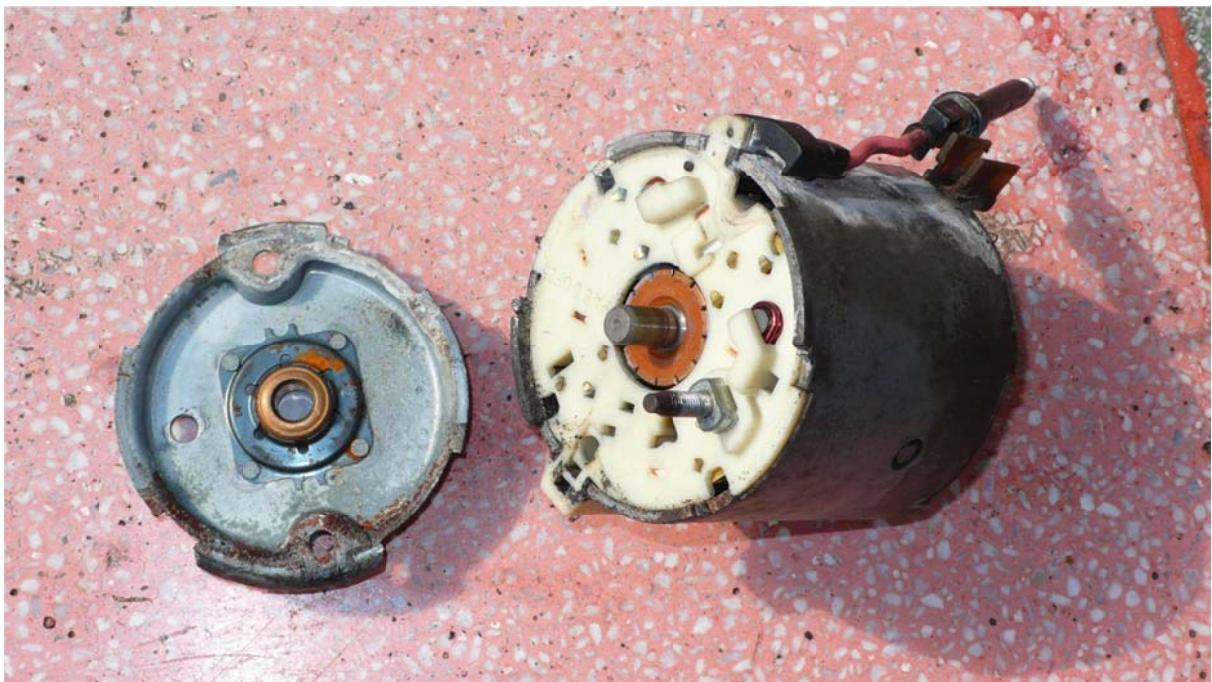
Picture-7: Motor with rear cover removed.

13. The rear cover can then be removed (Pic-7), revealing the white plastic brush-carrier assembly. This can be simply pulled out (Pic-8)
14. The overhaul of the motor will be covered in more detail separately, but briefly:

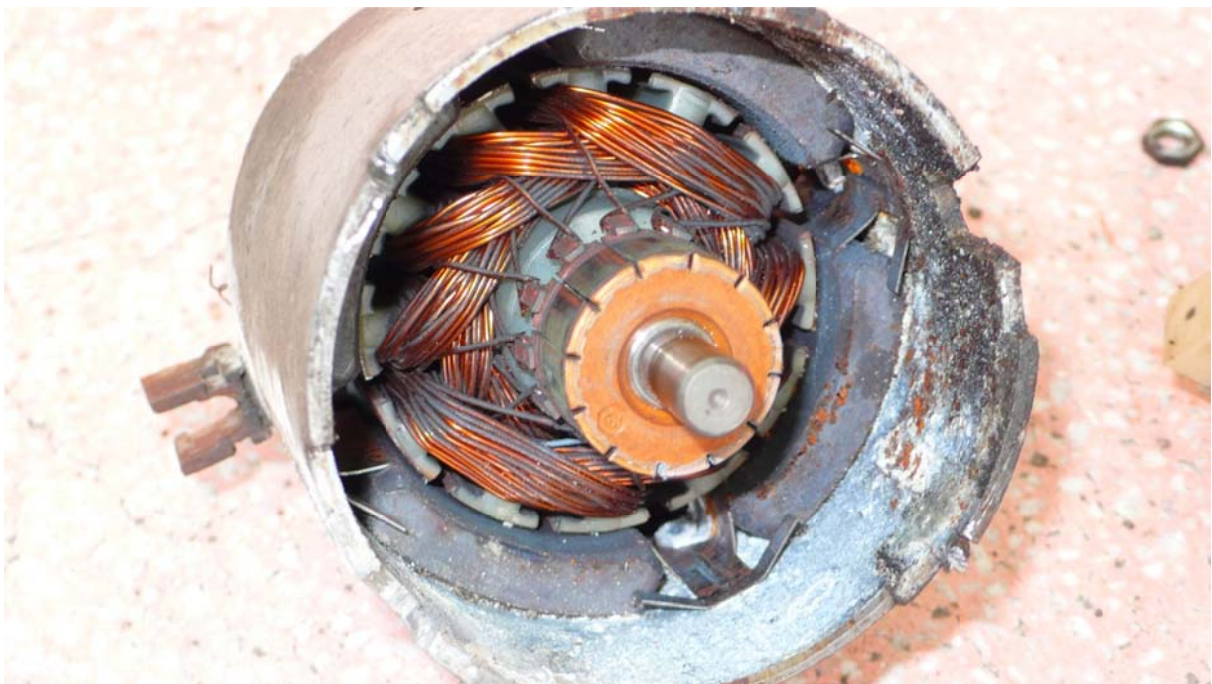
Picture-10: Motor commutator and windings could do with a clean. Note ceramic magnates are held in by spring-clips

- a. Clean the windings with some alcohol
 - b. Clean the commutator ring with fine emery or wet-n-dry paper.
 - c. Check that the front bearing rotates freely. Try clean with alcohol and oil if gritty.

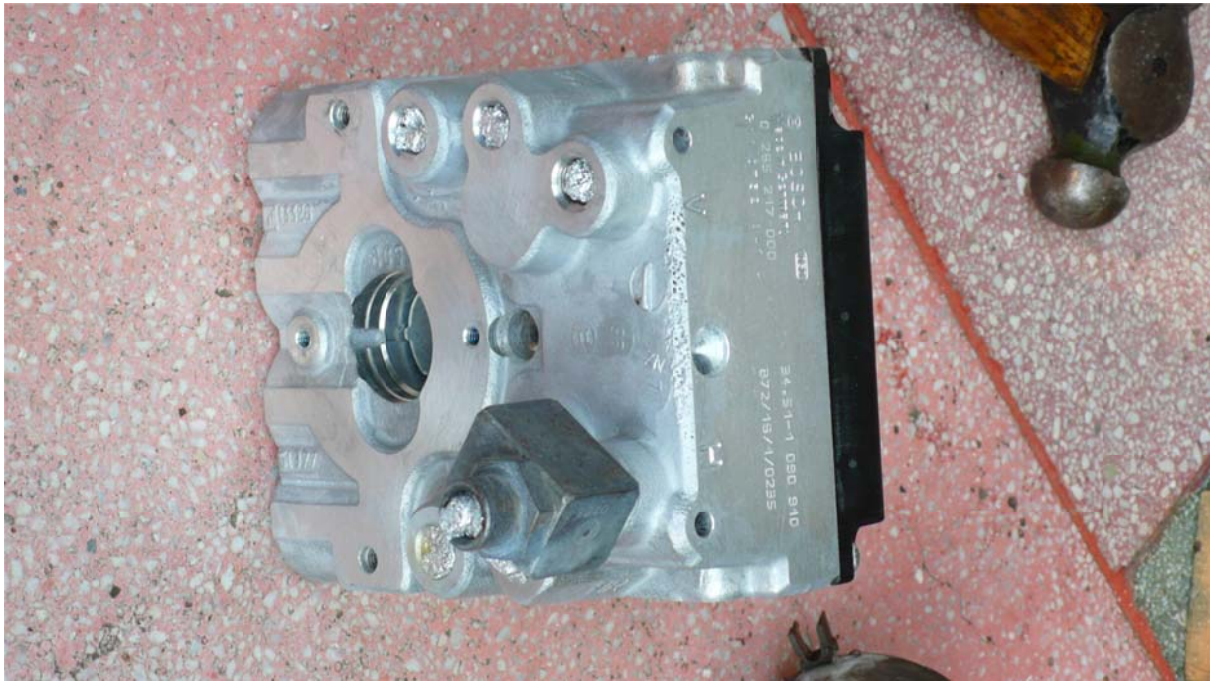
Picture-11: The valve-block is further cleaned with alcohol and/or metal cleaning solution.

- g. Otherwise, reassemble the motor.
 - h. Lightly grease the front eccentric cam- ring ready to replace into the valve-block.
15. The valve-block can then be carefully cleaned using alcohol (Pic-11), or for more severe cases a solution such as POR-15 Metal Prep works well, but try to keep this away from the pump mechanism and bearings (Pic-12).

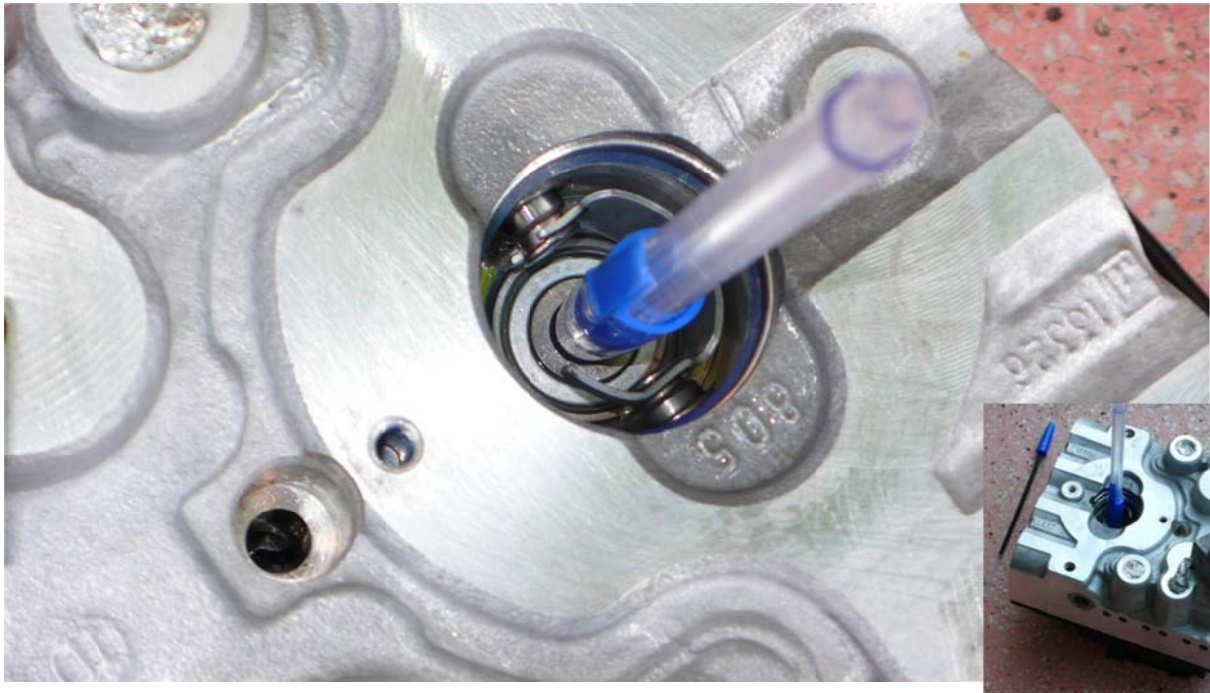
Picture-13: using some WD-40 and the end of a *Bic* biro to rotate it, it was freed-up and some Isopropyl alcohol was then used to clean it.

16. Check that the pump bearing is not seized (Pic-13)
17. Re-grease the pump bearing and mechanism with general-purpose (light) lithium grease.
18. Replace parts in reverse order to removal.
